For Pleasure

Crews repair pier following hurricane

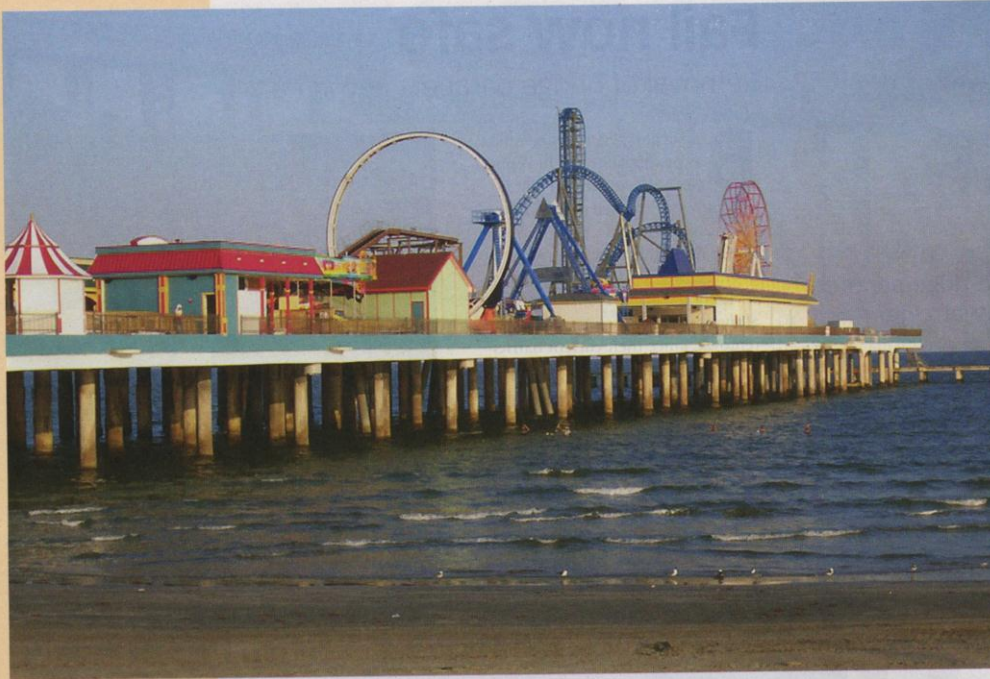
The single-component micro silica enhanced repair and restoration material achieved more than 9,000 psi at 28 days.

The Galveston Island Historic Pleasure Pier reopened this past summer following a year of extensive repairs to pilings, beams and other structural elements.

The nozzlemen, who wore life jackets on the job, pneumatically pumped more than 1,400 3,000-lb bulk bags of QUIKRETE Shotcrete MS – Fiber Reinforced through a hose from a silo system to make the repairs. According to local tourism officials, the post-Hurricane Ike restoration of the Galveston Island Historic Pleasure Pier helped Galveston to its best peak tourism season ever.
